## Pipe assembly blows off, strikes operator

### Purpose of this report

Number: 2005144250175

Core activity: Well stimulation

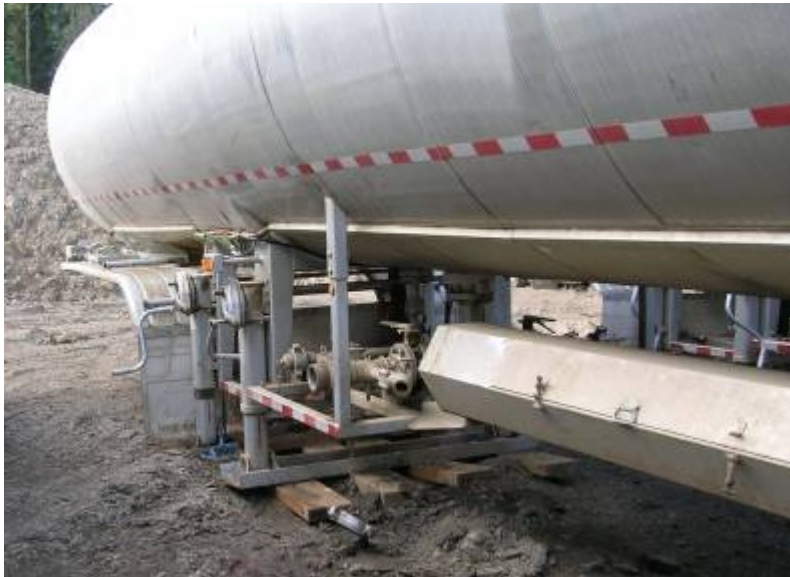
At a well stimulation site, an operator needed to release excess carbon dioxide (CO<sub>2</sub>) from a mobile tanker unit, known as a queen. The queen was parked between two other queens, so the excess gas could not be released directly out to the side. To redirect the venting gas to the front of the queen, the CO<sub>2</sub> operator constructed a pipe assembly using available piping components. When the CO<sub>2</sub> operator opened the discharge valve to release the excess CO<sub>2</sub>, the pressure of the venting gas unthreaded the pipe assembly and it spun counterclockwise. The pipe assembly struck the CO<sub>2</sub> operator, causing fatal injuries.

The engineering report concludes that the most likely cause of the incident is that compressed gas escaping from the end of a 45-degree pipe elbow created a thrust. The relative orientation of the thrust and distance of the 45-degree elbow from the axis of rotation of a threaded pipe joint caused the pipe to unthread. The threaded connection was not tight enough to resist the torque created by the escaping jet of gas. The engineering report also concluded that the white substance on the pipe threads may have acted as a lubricant, allowing the pipe to unthread at a lower torque.

The pressure of the CO<sub>2</sub> gas where it impacted on the angled pipe assembly caused it to spin off the thread mount of the outlet.
